Treatment Design of An Unstable Slope

Zeng Yuping

Sichuan College of Architectural Technology, Deyang, Sichuan, China

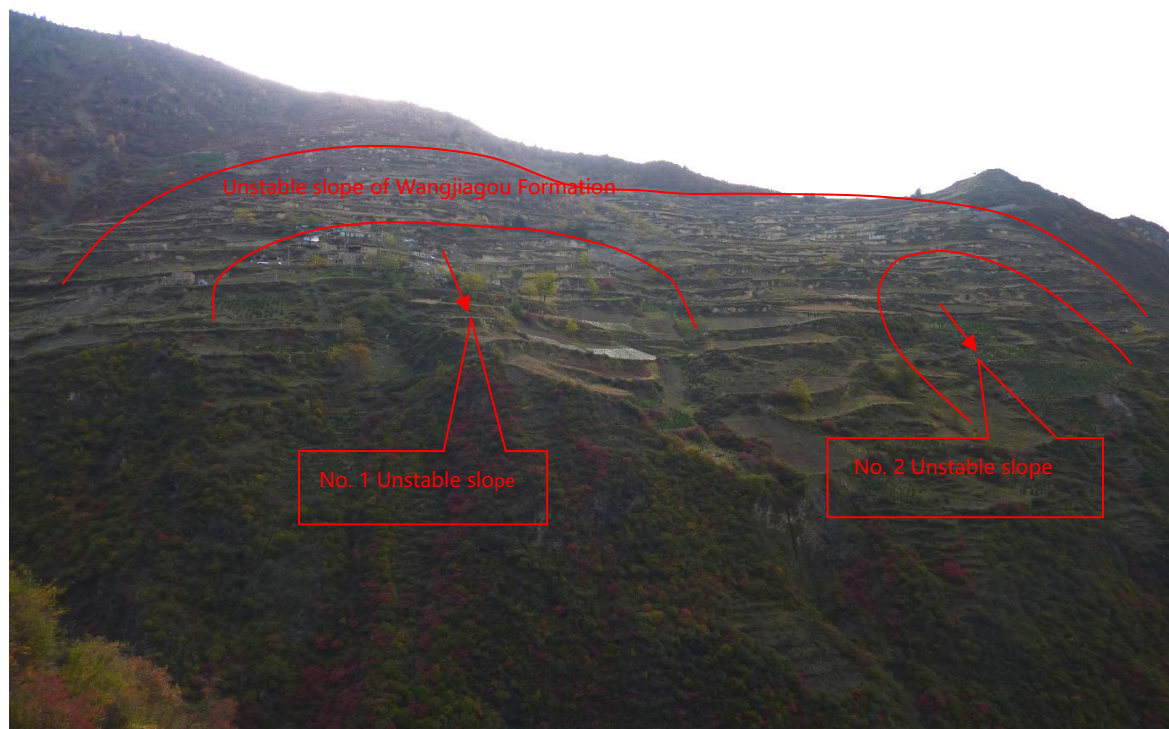
Figure 1. Topography of Unstable Slope of Wang Jiagou Formation

the whole slope body is in the shape of an armchair on the plane, with the Mother Temple as the boundary on the north, gullies on the south, the foot of the mountain slope at the rear edge on the west and steep cliffs at the front. the length of the slope is 980m, the width is 586m, the overall slope direction is 65°, and the covering layer is cohesive soil, with a

thickness of 8~12m and a total volume of about $574 \times 104 \text{ m}^3$, which is large (see figure. 1). At present, the whole slope is in a basically stable state, but local instability and deformation may occur under unfavorable working conditions such as rainfall. According to the slope topography and its deformation characteristics, the possible deformation and instability of the slope is mainly located in the front of the slope. At the same time, combined with the field survey data, the distribution of surface cracks, deformation characteristics and threatened objects are analyzed, and the local areas where instability may occur are divided into unstable slope No. 1 and unstable slope No. 2.
