Analysis and Improvement Research on Oil Leakage Mechanism of Large Bore Engine Oil Seal

Abstract: This article conducts a systematic mechanism analysis on the continuous oil leakage of the rear oil seal of the 16M33 series diesel engine used for power generation after running for about 40 minutes under rated conditions during in plant testing. Based on the study of fault phenomena and key parameters, the root cause of oil leakage was deeply analyzed from multiple dimensions such as structural dynamics, tribology, and assembly technology. It was identified that the main causes were the excessive runout of the flywheel housing, uneven pressure of the oil seal spring, and mismatched surface roughness of the crankshaft. Based on this, a comprehensive improvement plan covering structural optimization, process innovation, and standard reconstruction was proposed. Through theoretical calculations and bench tests, the improvement measures proposed in this study have effectively achieved the goal of reducing the failure rate of such oil seals by 80%, and provide important references for the reliability design of rotary shaft seals in large bore engines.

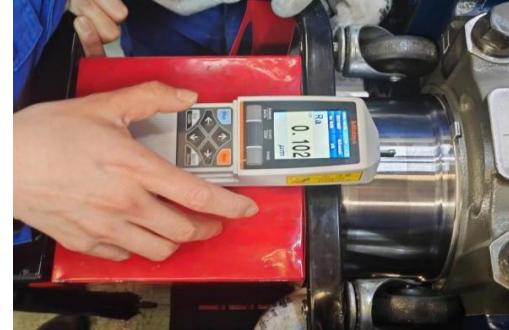
The surface roughness of the crankshaft is seriously low: we measured and found that the surface roughness of the crankshaft journal of 6 faulty machines is about $R_a 0.102 \mu m$, which is lower than the national standard requirement ($R_a 0.2 \sim 0.8 \mu m$). Low crankshaft roughness can lead to loss of lubricating oil film retention ability and a sharp increase in frictional heat. A very thin and stable lubricating oil film is required between the oil seal lip and the shaft neck for lubrication and heat dissipation. Appropriate micro protrusions (with a certain degree of roughness) can help maintain this oil film like "micro oil storage pits". When the surface is too smooth ($R_a 0.102 \mu m$), this oil film cannot be stably formed and maintained, and the lip and journal are prone to transition from fluid lubrication to boundary lubrication or even dry friction state. When the contact surface between the crankshaft and the oil seal lacks effective lubrication, the frictional force between the lip and the ultra smooth journal will significantly increase, generating a large amount of frictional heat. This leads to a rapid increase

in temperature in the lip contact area, which may exceed the instantaneous tolerance limit of fluororubber, causing Joule heating effect (thermal hardening), softening, and even ablation of the material, thereby permanently damaging its sealing performance in a short period of time, as shown in Figure 1.

Figure 1. Actual Measurement of Roughness on the Installation Surface of the Crankshaft Rear Oil Seal

(2) Correction of surface characteristics of crankshaft journal: Adjust the surface roughness of the journal at the fit between the crankshaft and the oil seal lip from $Ra0.102\mu m$ to the ideal range of $Ra0.2\sim0.8\mu m$. This can be achieved through precision grinding combined with honing technology to create a suitable microstructure that can store lubricating oil.
