Geological Characteristics Analysis and Treatment of a Dangerous Rock Deformation Body

Zeng Yuping

Sichuan College of Architectural Technology, Deyang, Sichuan, China

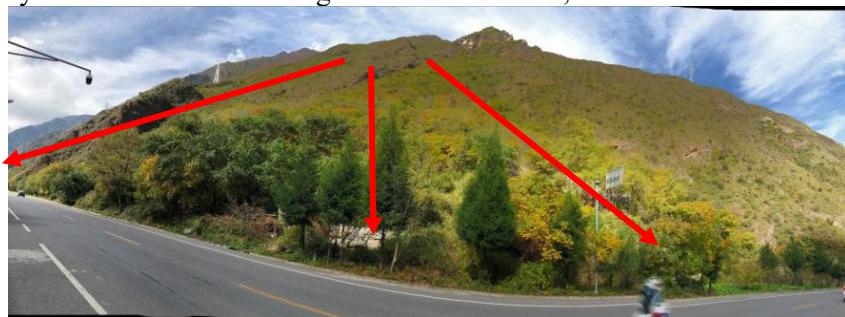
Figure 1. Overall Slope Topography of the Exploration Area

The collapse is located on the mountain on the north side of the new village gathering point. The terrain slope of the mountain is steep, generally $30^\circ \sim 50^\circ$, and it is steep locally, and its slope can reach more than 80° , which is almost vertical. There are many dangerous rock belts and dangerous rock monomers on the slope, mostly developed in steep slopes and steep cliffs. The landform of the exploration area belongs to erosion and erosion slope landform, and there is no wide and gentle platform in the area, all of which are slopes. This survey adopts independent coordinate system, with the highest elevation of 2128m, the lowest elevation of 1608m and the relative height difference of 520m (see Figure 1). According to the field investigation, the landforms in the exploration area can be divided into three landforms: slope landform, steep cliff landform and gully landform, which are as follows:

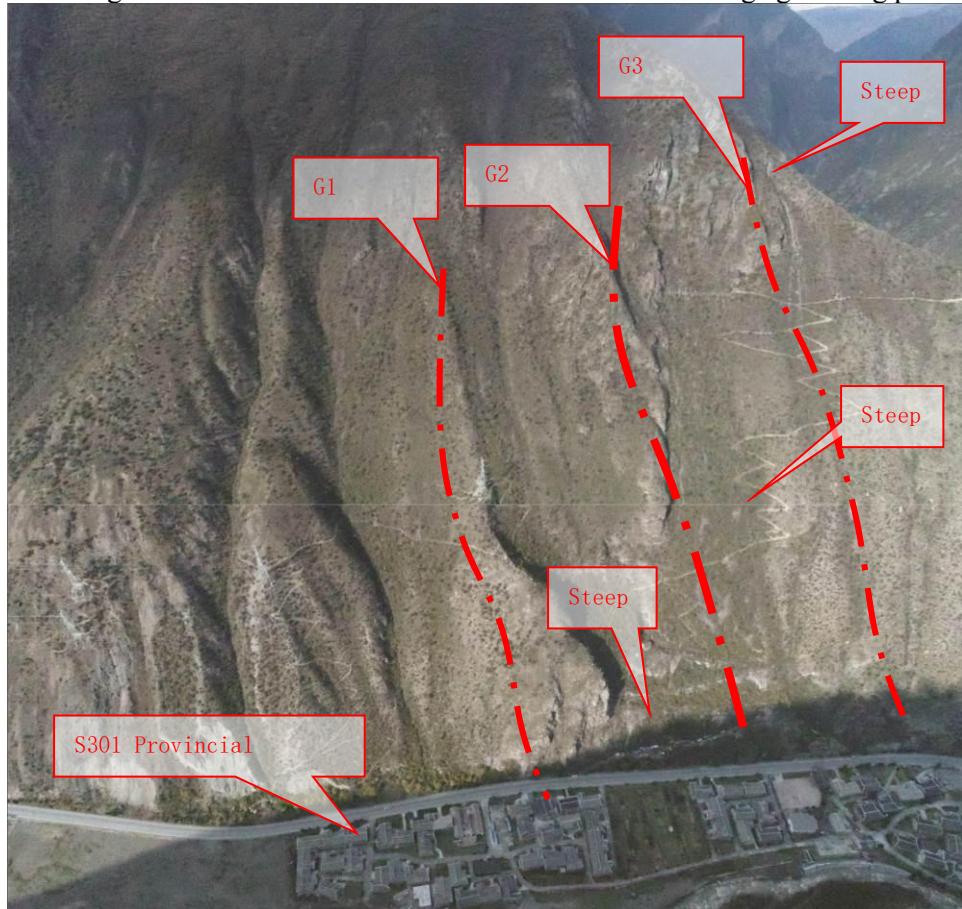
Figure 2. Topographic Map of the Exploration Area

Three large gullies are developed in the exploration field (see Figure 2), among which G1 gullies are oriented at 336° and about 450m long. The gullies are developed at the right lower part of WYD4 dangerous rock zone and WYD5

dangerous rock zone. There are many slope stones accumulated in the gullies, mainly those after WYD4 and WYD5 collapse. Below the gullies are provincial roads and new village gathering points. G2 gully is about 320° in direction and 500m in length. The upper part of the gully is developed at the right lower part of WYD6, and its lower part passes through the slope toe of WYD11. There are many slope stones accumulated in the gully, mainly concentrated in the lower part of the gully near provincial roads. Below the gully are provincial roads and new village gathering points, without buildings; G3 gully is about $310^{\circ}\sim 330^{\circ}$ in direction and about 500m in length. The upper part of the gully develops below WYD15 and on the left side of WYD13. There are many slope stones accumulated in the gully, mainly concentrated in the lower part of the gully near provincial roads. Below the gully are provincial roads and new village gathering points.
