Analysis of the Formation Mechanism of a Landslide

Abstract: This paper describes the geological conditions of a landslide in detail, analyzes the landslide formation factors from the aspects of topography, stratigraphic lithology, rainfall, human factors, seismic action, etc., and concludes that the landslide formation mechanism is as follows: the landslide soil contains gravel silty clay, which is affected by rainfall and groundwater, reduces its mechanical properties, and the landslide is deformed.

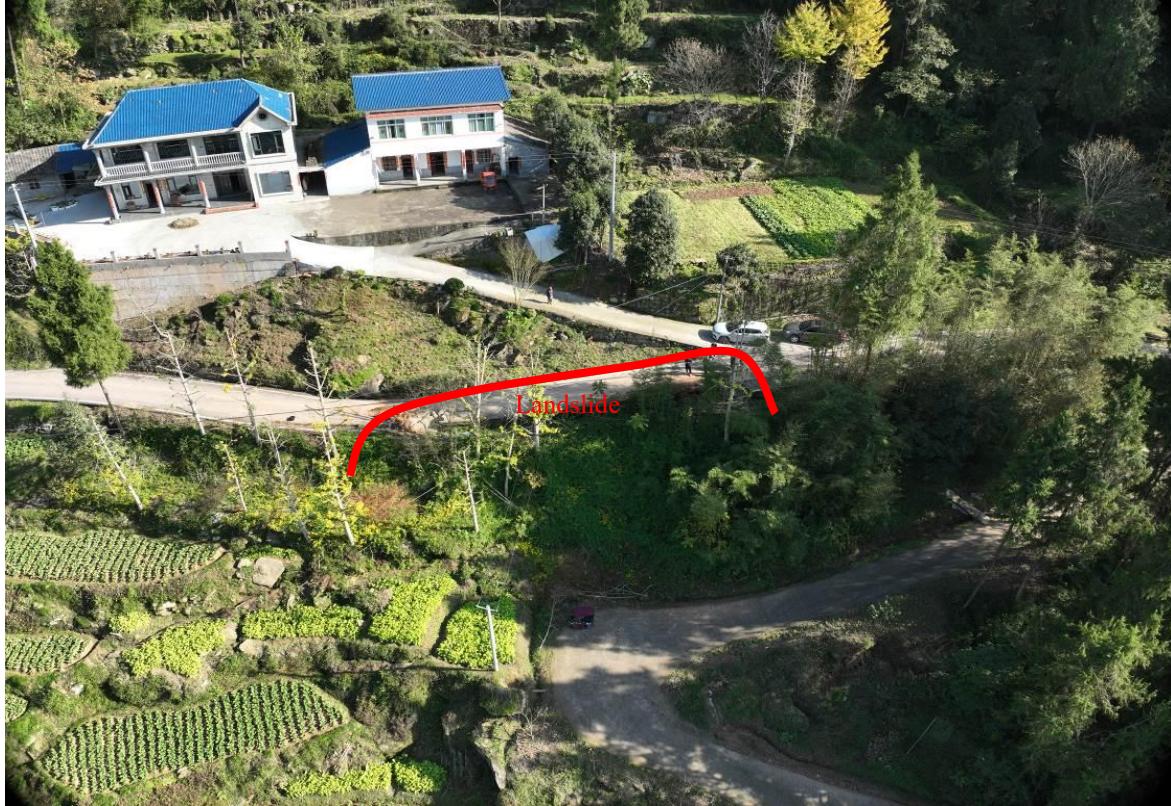
Figure 1. Landslide Terrain

the southern area is low-mountain terrain. The landslide disaster area is located in the low mountainous area of tectonic erosion, with an altitude of 400m~500m. The area where the

landslide is located is a ruined slope landform, and the terrain of the landslide area is gentle and the terrain is in the form of steps. The landslide topography is shown in Figure 1.

mountainous area with tectonic erosion, the overall topography of the landslide belongs to the residual slope accumulation slope terrain, the topography of the landslide area is stepped, the rear part of the landslide is the Tongcun road platform, the overall topography of the slope is a steep hill with a height of about 2.5m~4.0m, and the leading edge is gentle cultivated land.
