Analysis of Deformation Characteristics of a Landslide and Its Treatment

Abstract: The deformation characteristics of a landslide in guangyuan are described in detail. Although the landslide is stable as a whole, its trailing edge is still in the process of continuous creep deformation. Under the induction of external factors such as heavy rainfall, local collapse or even large-area instability may occur at any time. Through analysis, anti-slide pile engineering is adopted to control landslide.

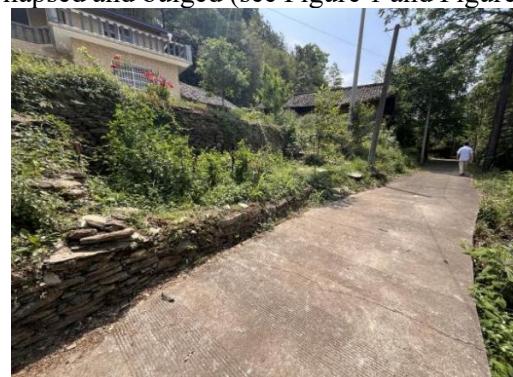
According to field investigations and interviews, most of the deformation signs of the landslide are concentrated at the trailing edge. In August 2023, affected by heavy rain, local collapse and sliding occurred in multiple parts of the slope, with a maximum deformation displacement of about 10 cm. A large number of tensile cracks were formed on the landslide mass, with crack widths ranging from 0.01 to 0.1 m, extension lengths ranging from 2 to 25 m, and extension depths ranging from 0.1 to 2.5 m. Strong deformation caused the road at the rear of the landslide mass to crack and move downward, and the rubble retaining wall outside the road collapsed and bulged (see Figure 1 and Figure 2).

Figure 1. Road Crack on the Right Side of Landslide Trailing Edge

Through the analysis of the landslide survey results, taking into account the construction environment, economic rationality and environmental adaptability of the prevention and control project, and combined with the on-site construction planning, the landslide prevention and control project is arranged in a targeted manner. According to the work results, on the basis of analyzing the landslide mechanism, the following treatment scheme is proposed: An anti-slide pile project is set up on the trailing

edge of the landslide, and the anti-slide pile is distributed in a straight line in the middle of the trailing edge of the landslide area, with a length of 105m.

There are 22 anti-slide piles, the pile core spacing is 5m, all of them are cantilever piles, the total length of pile is 15m, of which the upper free section is 8m long and the lower embedded stable stratum anchoring section is 7m long. Anti-slide pile section size 1.2×1.5 m, C30 concrete pouring.

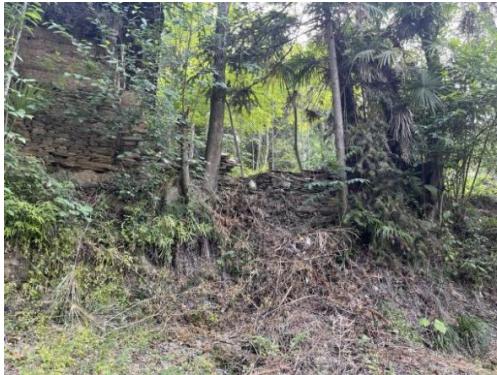
Figure 2. Left Slip of Landslide Trailing

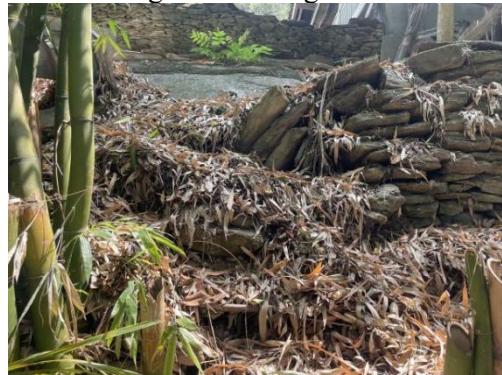
On-site investigations reveal that local collapse is well-developed on the slope, mainly concentrated in four specific locations at the trailing edge, with the following characteristics: No. 1 Collapse: Located at the trailing edge of the landslide, with a range of about 10 m in length, 2 m in width and 1.5 m in thickness, and a total volume of approximately 30 m³. It is mainly the local collapse deformation of surface loose soil, and the surface vegetation of the slope has been destroyed.

No. 2 Collapse: Located at the trailing edge of the landslide, with a range of about 3 m in length, 2 m in width and 1.5 m in thickness, and a total volume of approximately 9 m³. It is mainly caused by the local collapse deformation of surface loose soil, leading to the local collapse deformation of the road berm, with the berm base damaged and the pavement partially collapsed.

Typical local collapse and building deformation are shown in Figure 3 and Figure 4.

Figure3.Collapse at the Middle of the Trailing Edge of Slope Body

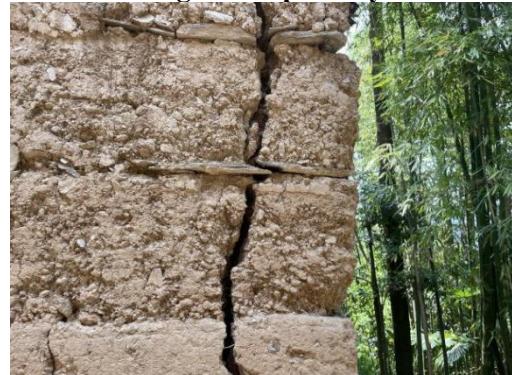
At present, the buildings on the slope are mainly pedestrian cement roads and self-built houses, with deformation mainly manifested as wall cracks, road cracks and extrusion damage:

Figure 4. House Cracks
