Presumptive Study of Temperature and Residual Strength of Desulfurization Tower Structure During and after Fire

Keywords: Steel Structure Desulfurization Tower; Fire; Temperature Estimation; Residual Strength

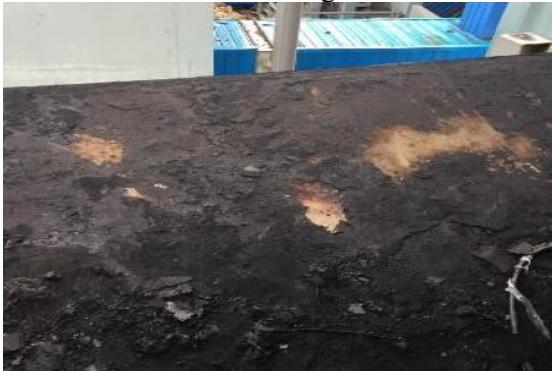
Figure 1. Current Status of Desulfurization Tower Structure

This steel structure desulfurization tower was designed and constructed in 2017. The total height of the desulfurization tower is 60m, and the tower is divided into three functional areas from bottom to top, which are slurry area (main function is desulfurization and mist removal), wet electric area (main function is electrostatic dust removal), and chimney area. The fire was caused by the weldments falling on the PVC pipes in the mist removal area, and the fire lasted for about 53 minutes. After the fire, observing the whole FGD tower, the paint on the outer wall of the slurry area is basically intact, the paint in local area is bulging, the glass scale mastic on the inner wall is carbonized and turned black, but still attached to the inner wall; the spraying device is twisted and deformed. The structural status of the desulphurization tower after the fire is shown in Figure 1.
